MARYLAND HISTORICAL TRUST

CE-931
MAGI #0809315435

INVENTORY FORM FOR STATE HISTORIC SITES SURVEY

Lusby House

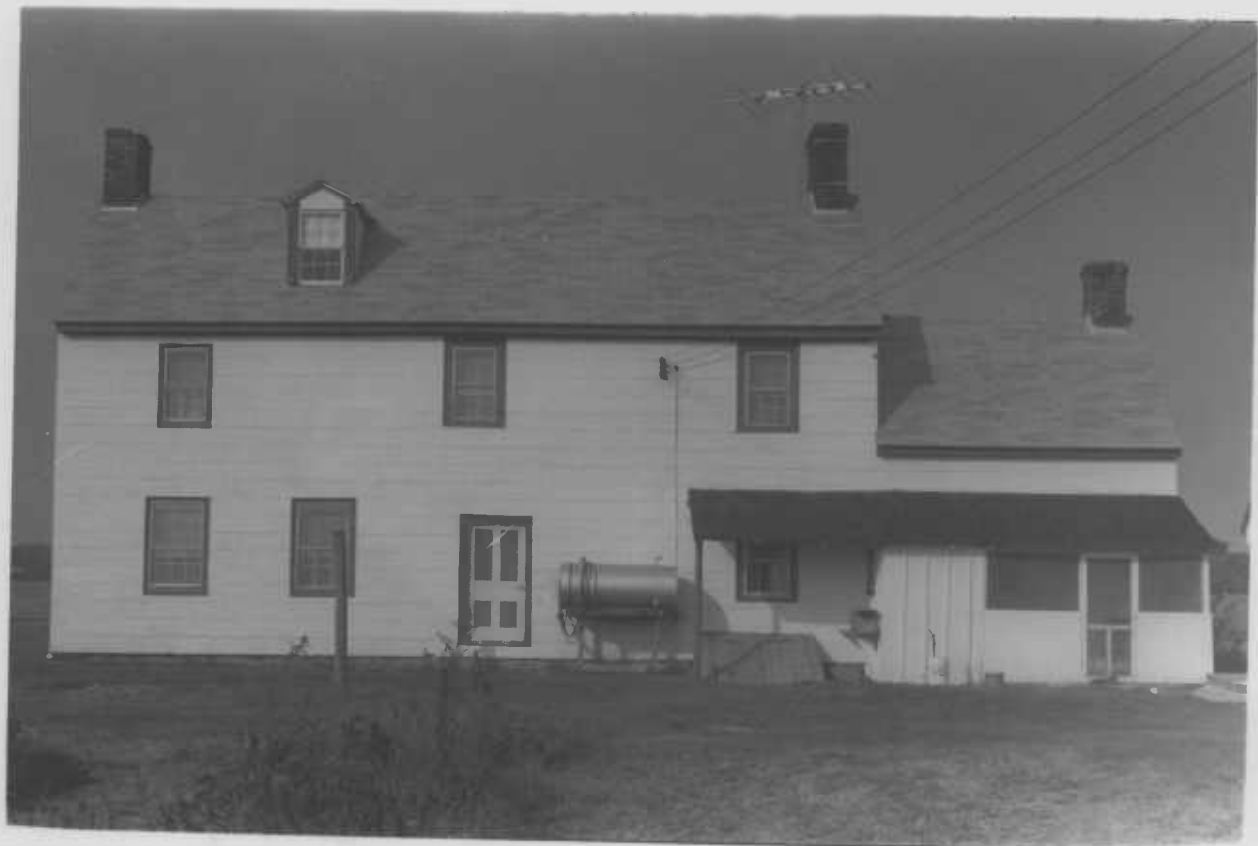
(29)

The south side has an asymmetrical placement of lights on the first floor. A central four panel door has two six-over-six sash to the east. Three six-over-six sash are evenly spaced across the second floor. A single six-over-six dormer lights the western half of the attic. Shutters were attached at one time and their pintels attest to that fact.

Lusby House
SOUTHERN ELEVATION
~~WALL BRACKET~~

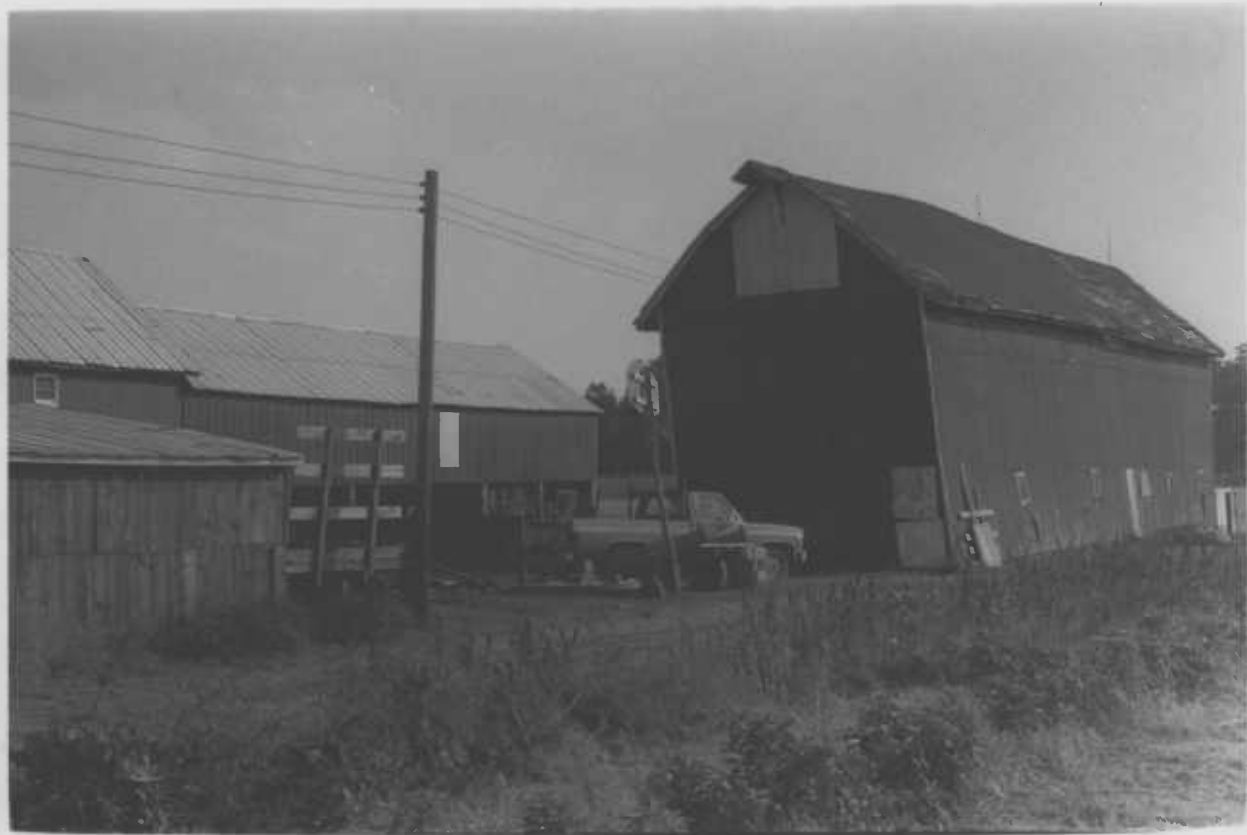
(26)

NORTHWEST ELEVATION
R W LANGLETT, MD.
